## Primary Sedimentation Tank Bearings

<b>Industry:</b>	Sewage and Wastewater
<b>End User:</b>	Watercare Mangere, New Zealand
<b>Application:</b>	Peak Cap Bearing in Primary Sedimentation Tanks
<b>Thordon Grade:</b>	SXL
<b>Date of Original Installation:</b>	2010

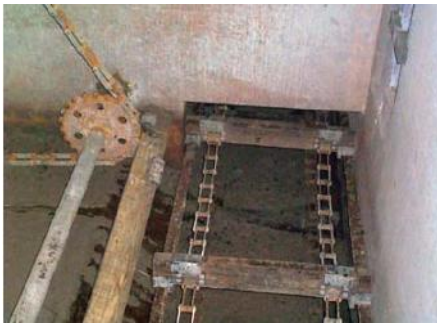
**Typical PST (primary sedimentation tank) setup**

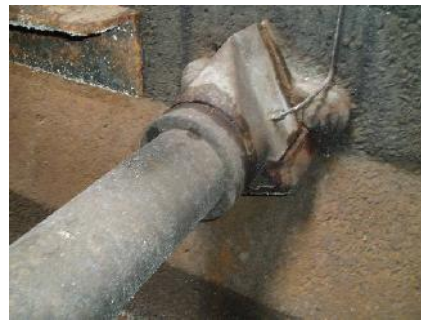
**Peak Cap bearing, shaft and grease line**

In 2010, a trial was run at Water Care Mangere where Thordon SXL bearings replaced greased white metal (Babbitt) bearings in the Primary Sedimentation Tanks. The shafts are made of mild steel and they run 24/7 at a very slow speed. One of the issues with the greased Babbitt bearings is the grease lines as they can be subject to damage from sticks, rags or trash moving through the tank. If the grease doesn't get to the bearings for any reason, then the bearings will gall, pick up or seize. Dewatering a tank in order to replace the bearings costs a lot of time and money.
